Analisis Properties of The New Produced Welded Parts – Regulated Spindels

This research work concerns to investigation properties (fitness for purpose) of new produced welded parts. Besides scientific this paper has practical meaning too. Investigations was prepared on the request of the Company MZT WABTEK AD, Skopje that produce and build in parts for railway vehicles. Subject of investigations are two new produced (non-used) welded parts named regulating spindles. These regulated spindels were produced by welding company i.e. subcontractor.

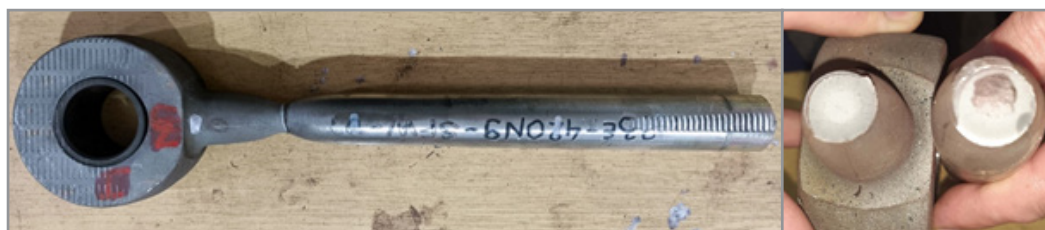
As can be seen from the figure 2, the spindle was fractured in the base metal, out of welded joint which is required during testing. It confirmed too that welding process was performed properly.

Figure 2b show fractured surface of the tested spindle. Typical cup and cone fracture can be seen. It obvious that plastic deformation during testing appeared [5].

Figure 2: Fractured spindle after tensile testing

Fracture of the spindle was out of the welded joint (weldment). Type of fracture is typical cup and cone. Hardness values across the welded joint are in accordance with standards (140-192 HB) requirement .

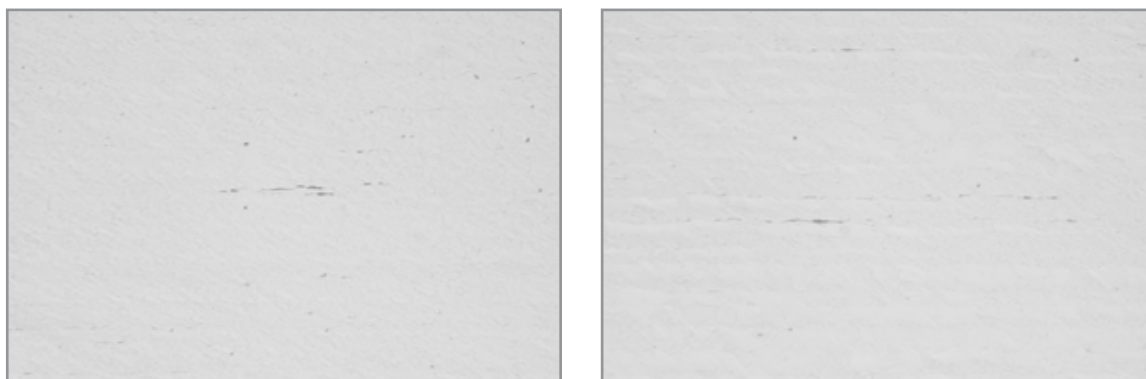
Polished metallographic specimens were used for the analysis of the material cleanliness i.e. presence of non-metallic inclusions. Magnification of x100 was used. Figure 3a represent content of non-metallic inclusions in the part1 of the spindle, and figure 3b represent the content of non-metallic inclusions in the part 2 of the spindle. Very similar content of inclusions in all specimens is noticed. Mainly sulphide type of inclusions are present. Anyhow, both materials are very clean concerning presence of non-metallic inclusions.

Figure 3 (a and b) Non-metallic inclusions in the both parts of the spindle
