## Analisis Properties of The New Produced Welded Parts – Regulated Spindels

*This research work concerns to investigation properties (fitness for purpose) of new produced welded parts. Besides scientific this paper has practical meaning too. Investigations was prepared on the request of the Company MZT WABTEK AD, Skopje that produce and build in parts for railway vehicles. Subject of investigations are two new produced (non-used) welded parts named regulating spindles. These regulated spindels were produced by welding company i.e. subcontractor.*

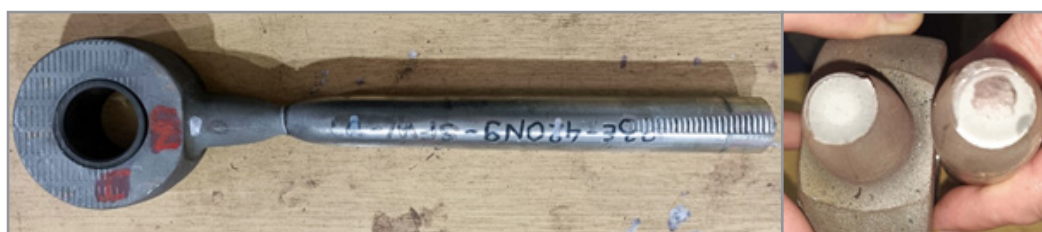
**Figure 2: Fractured spindle after tensile testing**

As can be seen from the figure 2, the spindle was fractured in the base metal, out of welded joint which is required during testing. It confirmed too that welding process was performed properly.

Figure 2b show fractured surface of the tested spindle. Typical cup and cone fracture can be seen. It obvious that plastic deformation during testing appeared [5].

Fracture of the spindle was out of the welded joint (weldment). Type of fracture is typical cup and cone. Hardness values across the welded joint are in accordance with standards (140-192 HB) requirement.
