An Innovative Approach for Amelioration of Acid Sulphate Soils in Nilwala River Basin

Abstract

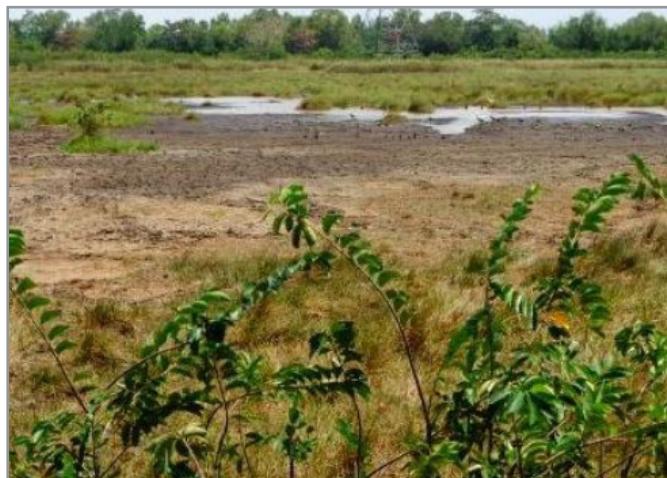
Figure 1: Area Affected By Extreme Acid Sulphate Conditions

A pilot area of the drainage channel segment of about 250 m length from NFPDP, consisting of about 5 acre of paddy land affected AS soils (Figure 1) was selected in the Godagama area closer to Agriculture research Station (ARS), Telijjawila with road accessibility. The only vegetation growing in the site is a
