Coal Acid Mine Drainage – Passive Treatment Lime Compost Drains – Three abandoned coal mined sites in Southern Illinois

Olga Moya Aranzubía

Illinois Department of Natural Resources, Office of Mines and Minerals, Abandoned Mined Lands Reclamation Division, 503 East Main Street, Benton, Illinois, 62812, United States of America

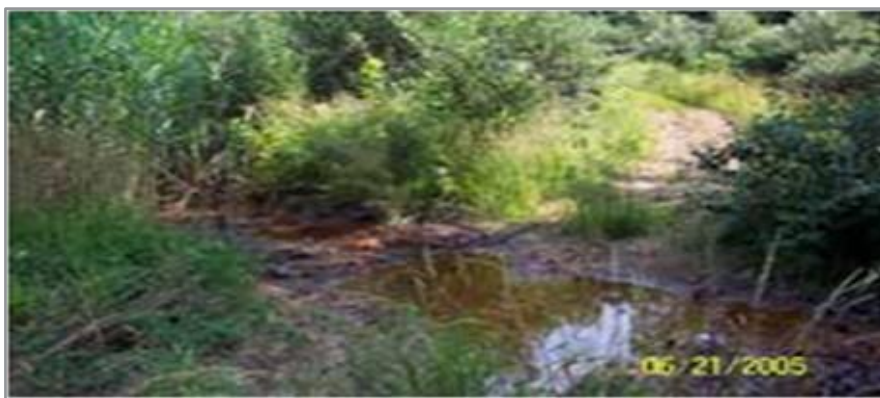
Figure 3: Marshall Equipment Acid Mine Drainage Seep 2007 (image: Olga Moya Aranzubia).

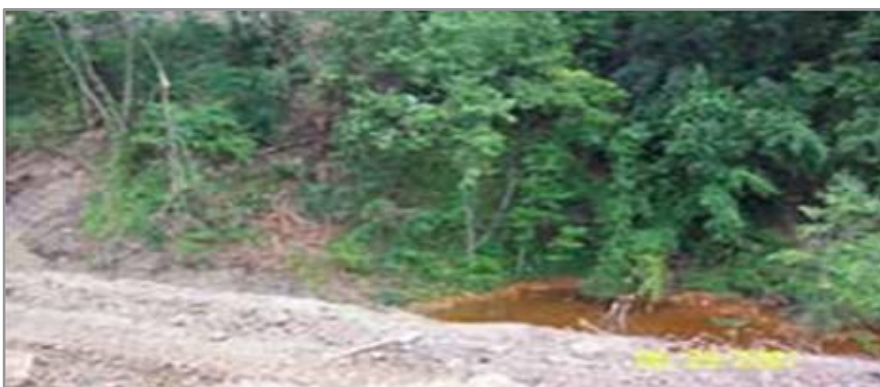
Figure 4: Marshall Equipment Phase Acid Mine Drainage Seep 2007 (image: Olga Moya Aranzubia).

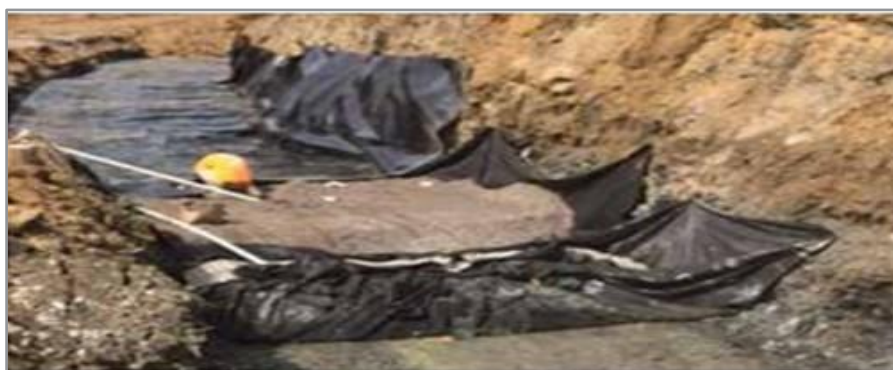
Figure 5: Richardson Coal Company LCD Construction (image: Olga Moya Aranzubia).

made it nearly impossible to ensure proper construction. This piping for sampling ports proved to be very hard to maintain completely vertical to the surface. It was also very difficult to ensure the connection between the vertical pipes for these sampling ports and the main pipe network, running within the drain, remained in place and functioning, once backfill material was placed and compacted. The entire pipe system was removed from subsequent designs (see figure 5 and 6).

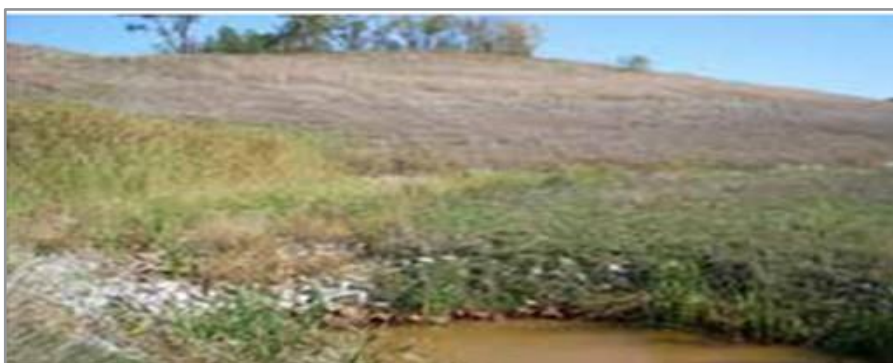
Figure 6: Marshall Equipment Reclaimed Highwall and LDC Sediment Basin 2010 (image: Olga Moya Aranzubia).

Another challenging aspect identified, post-construction of the LCD system, was the removal of settled solids. While riprap lined settling basins were very practical and easy to construct, they became difficult to maintain. These three LCD systems were built without any type of modelling for sizing, making it difficult to estimate the amount of precipitate that would be dropping out of solution at the outlet basins. While the original system at the Marshall Equipment site remains functional and precipitate sediment is being adequately handled, the Richardson Coal Company LCD system basins reached capacity after six years. A remedial project was completed to remove existing sediment from the basins at the Richardson Coal Company site. The clean out proved to be time consuming, due to the riprap

lining of the basins, making it costly. The most recently designed and constructed LCD passive treatment included the lining of the outlet basins with high density polyethylene, instead of the previously used 225mm riprap. This new lining material was introduced in an effort to ease the maintenance removal of precipitated solids settled, from the basin, as it will accumulate over time.
